Ashton Lagoon Restoration Project – Phase I of Works

Report to The Nature Conservancy, the Philip Stephenson Foundation
and the Grenadines Partnership Fund from Sustainable Grenadines Inc.
(SusGren)

23rd December 2017

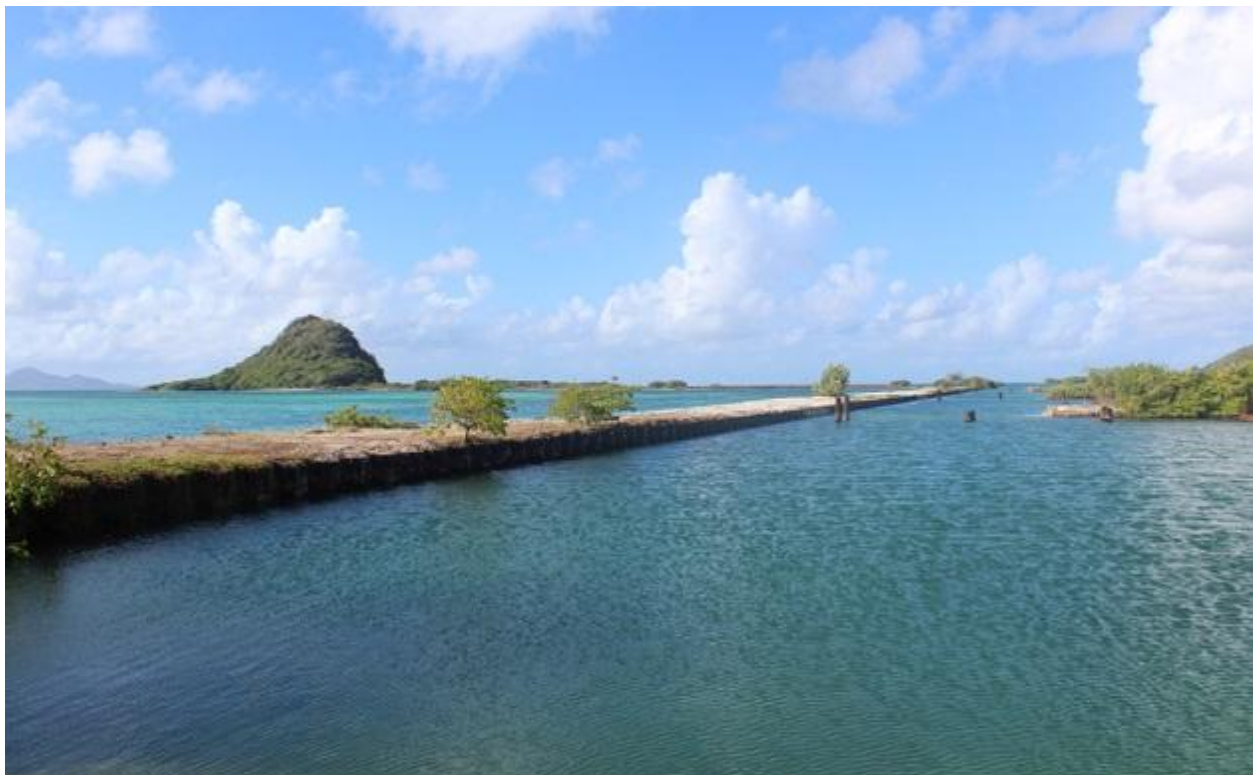
Newly opened channels in the abandoned pier in Ashton Lagoon at the end of phase I, December 2017.
Photo credit: SusGren.

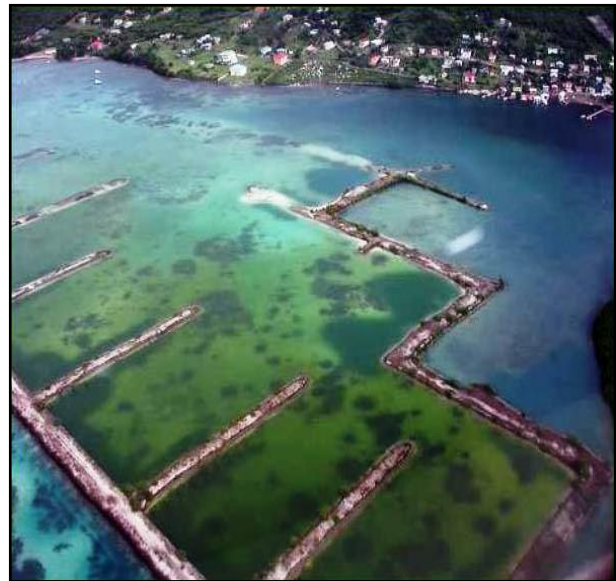
These structures caused various negative environmental and socio-economic impacts. The causeway blocked water circulation to the western half of Ashton Lagoon, causing water to become stagnant and marine life – including the once abundant lobster and conch populations – to die (**Figure 1**). The mangrove forest – the largest in Saint Vincent and the Grenadines – no longer functions as a fish nursery because it is cut off from the sea by a road. This has also prevented the wetland from draining properly, resulting in the death of 10 acres of black mangrove. Fishers have felt the impacts on their catches, and had to bear additional fuel costs because of the presence of the causeway, having to travel around the outside of Frigate Island to reach fishing grounds.

Figure 1: Stagnant water inside the abandoned pier prior to restoration works. Accumulation of nutrient had caused visible algal growth.

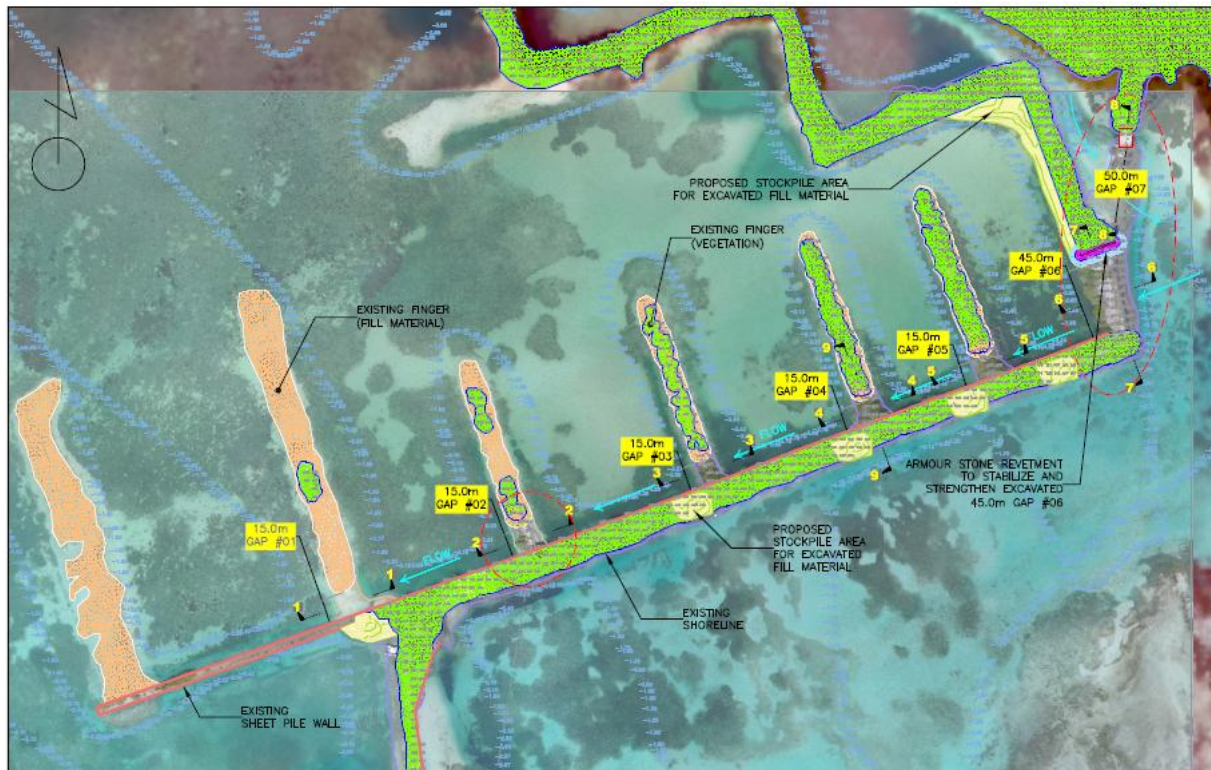
Figure 2: The engineering designs created by Smith Warner International. Gaps 1 to 5 have now been excavated thanks to funding from Philip Stephenson Foundation and the Grenadines Partnership Fund.

- 15 meter wide channels were excavated at five of the finger piers in the derelict pier structure (gaps 1 to 5 in **Figure 2**).
- Soil samples from all seven channels to be excavated were tested for contaminants (heavy metals and hydrocarbons) as a precaution. The results indicated negligible traces of contaminants so the material could be safely disposed of on site.

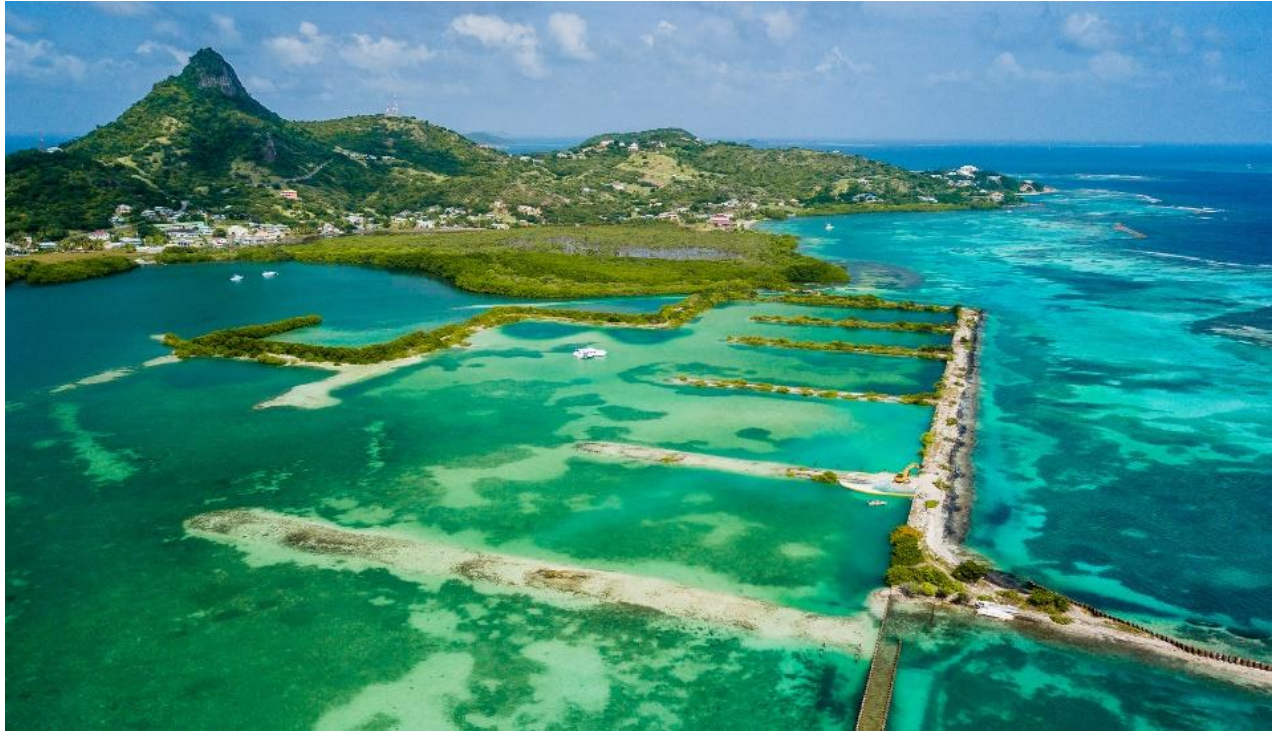
Aerial view of Ashton Lagoon during excavation of gap #2, November 2017. Photo credit: Arthur Daniel.

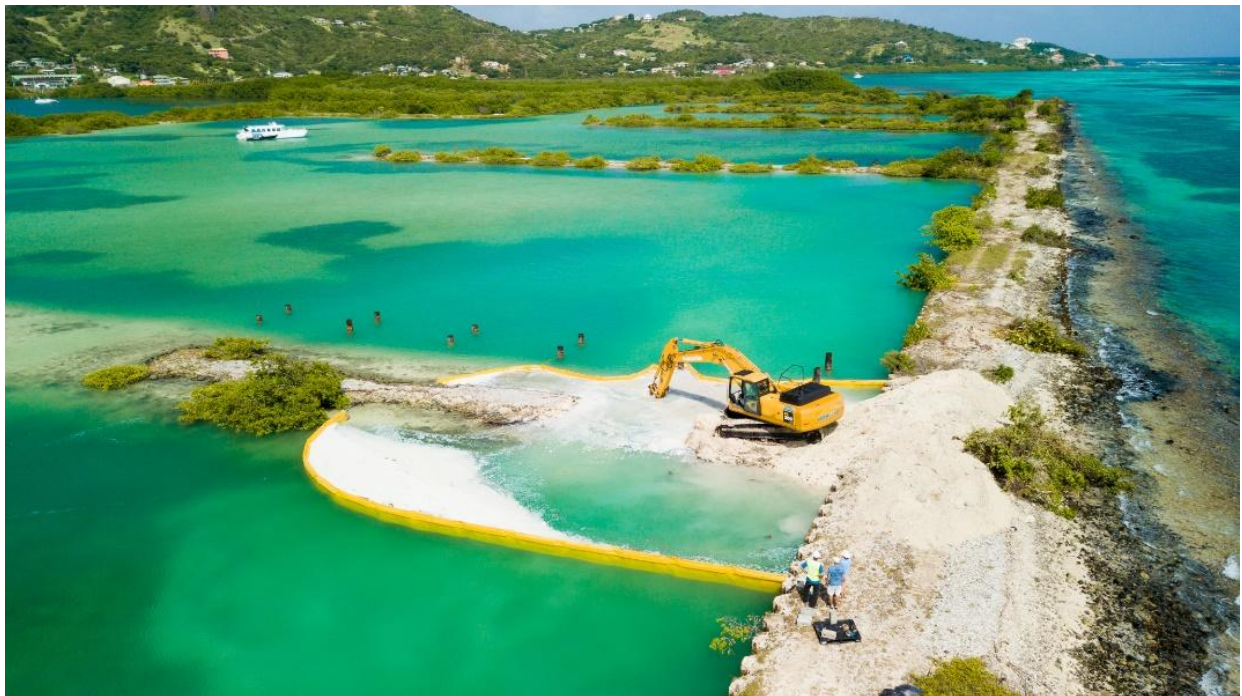
Excavation at gap 2. Turbidity barriers were deployed to prevent sediment from harming marine life. Photo credit: Arthur Daniel.

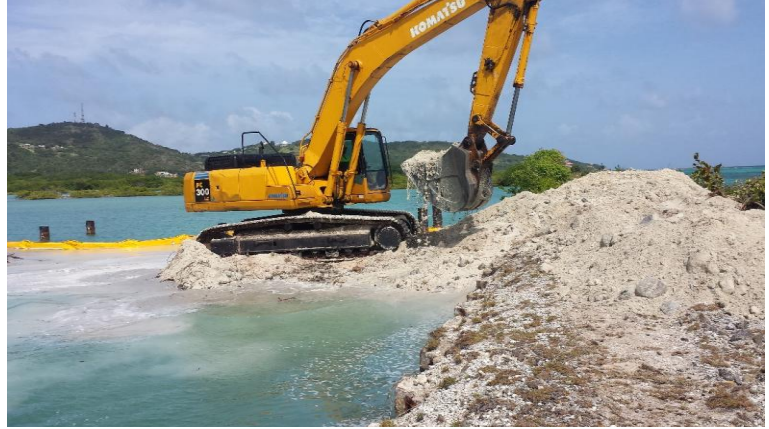
Top right: Excavator removing sand at gap 2.

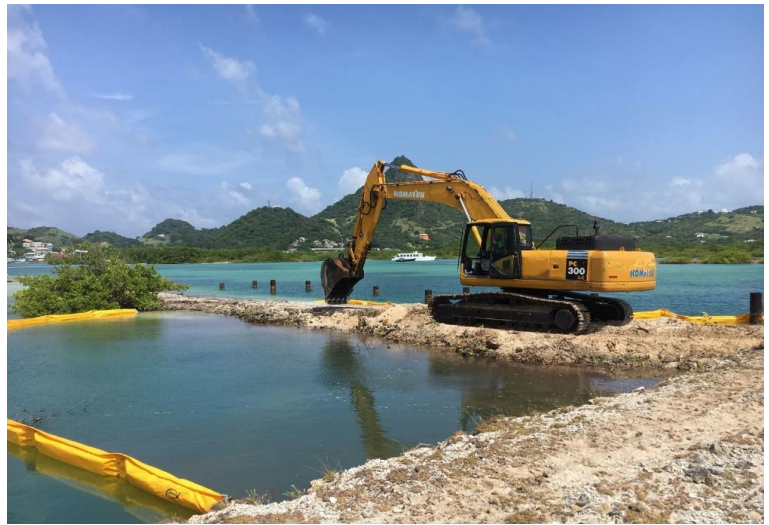
Right: Excavation at gap 3.

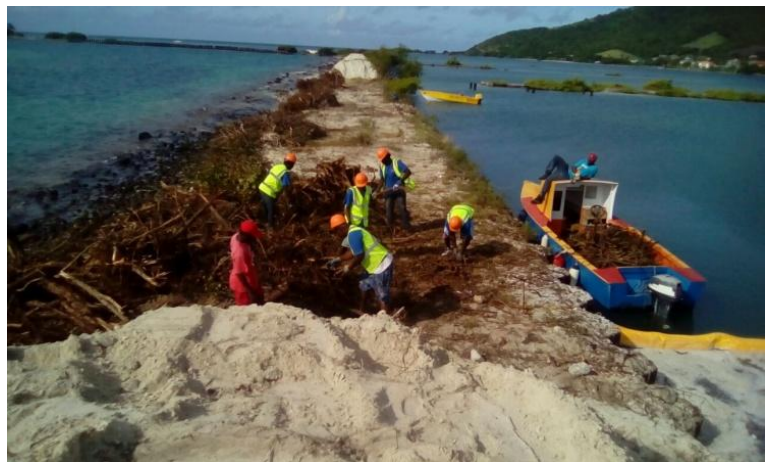
Bottom right: Clearing debris from the pier.

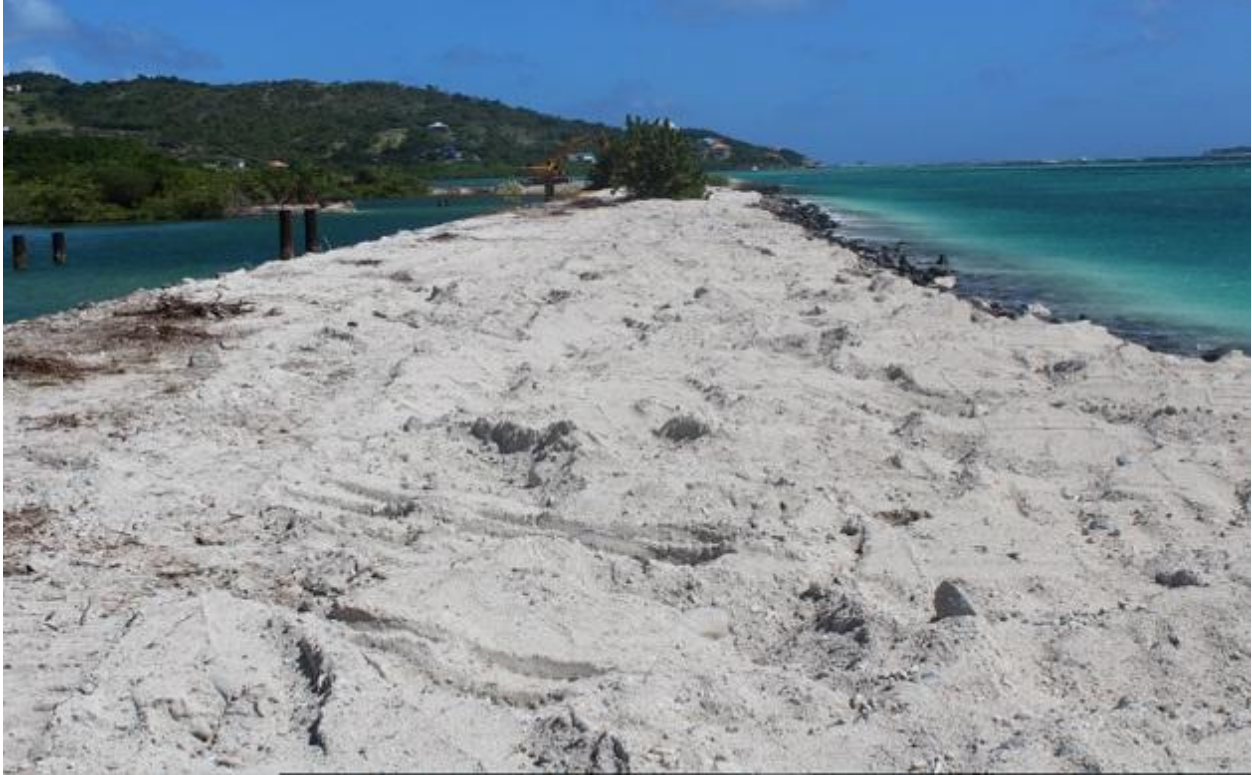
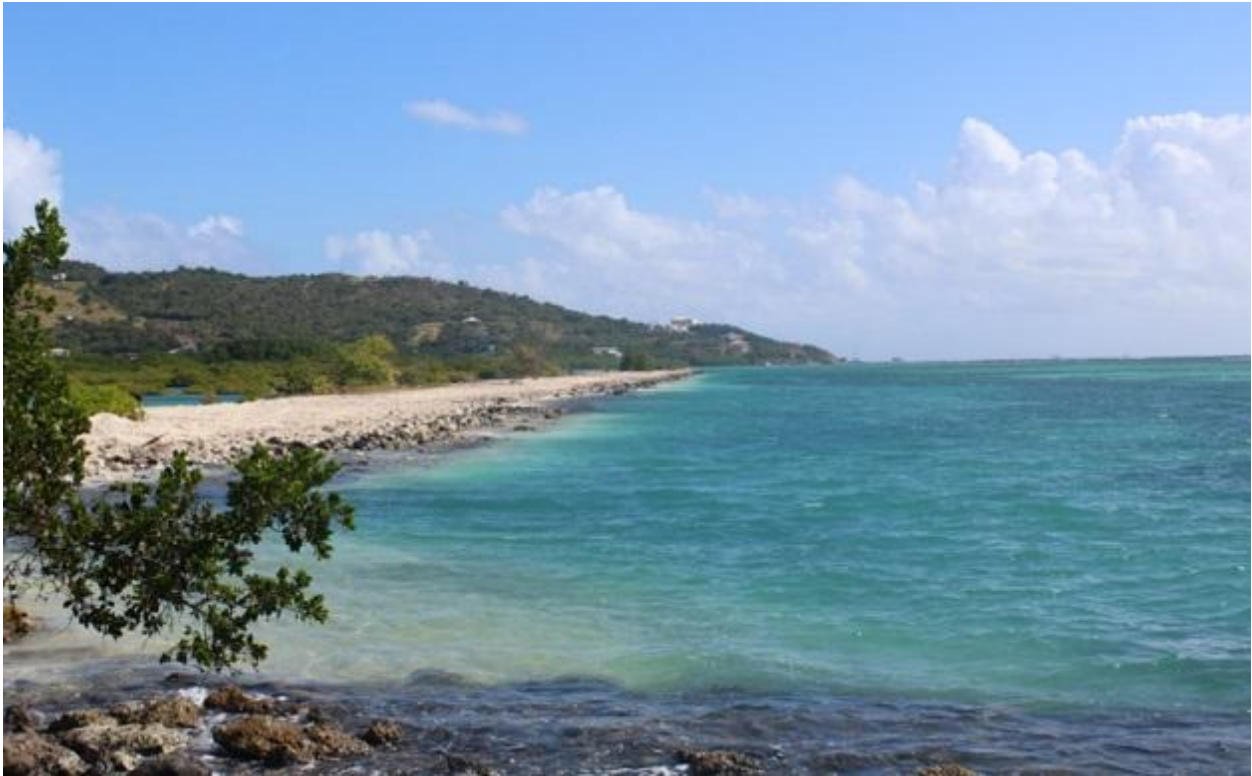
Above and below: The main causeway at the end of Phase I. The excavated sand has been placed and graded on the seaward side.

- Due to the favorable results of the soil tests, the contractor placed and graded the excavated sand along the seaward side of the derelict pier creating a semblance of beach. The aesthetics of the pier is drastically improved.
